# COMBINED FIRE AND HEALTH & SAFETY RISK ASSESSMENT.

| Address of premises: | St Michaels Close;<br>Lambourn;<br>Hungerford;<br>RG17 8FA |
| Date of fire risk assessment: | 5 <sup>th</sup> November 2025 |

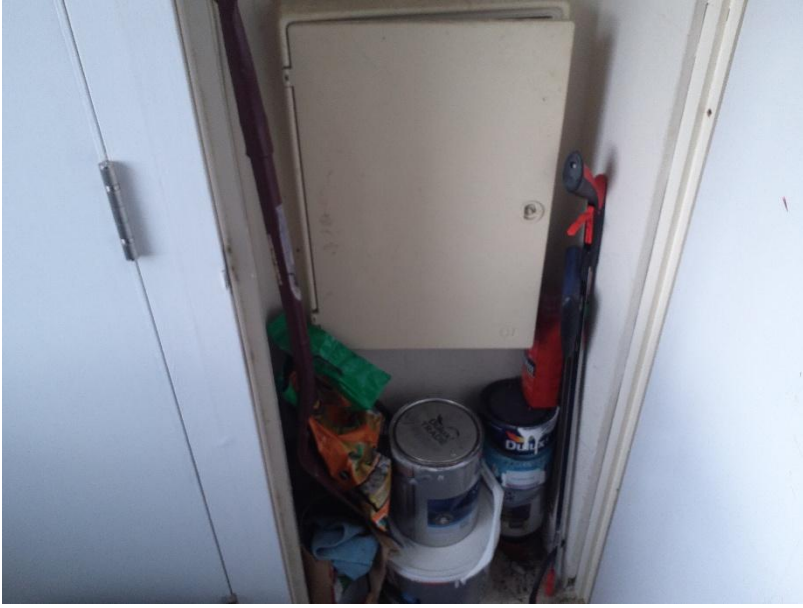
| <p>Housekeeping was found to be of a poor standard at the time of this assessment with the communal areas, communal cupboards and escape routes congested with residents' possessions and storage. It is recommended that the client arrange for the communal areas to be cleared as a priority and all residents reminded of the importance of maintaining sterile communal areas, communal cupboards and escape routes.</p> <p>Waste is well managed.</p> | | |

| Item | Recommendation | Priority | Timescale |
|---|---|---|---|
| 01 | <p>Housekeeping was found to be of a poor standard at the time of this assessment with the communal areas, communal cupboards and escape routes congested with residents' possessions and storage. It is recommended that the client arrange for the communal areas to be cleared as a priority and all residents reminded of the importance of maintaining sterile communal areas, communal cupboards and escape routes.</p> | 2 | B |

Ongoing action required

DH inspect communal areas and ticket items for removal.

Residents are reminded to keep sterile communal area via notice board and website.

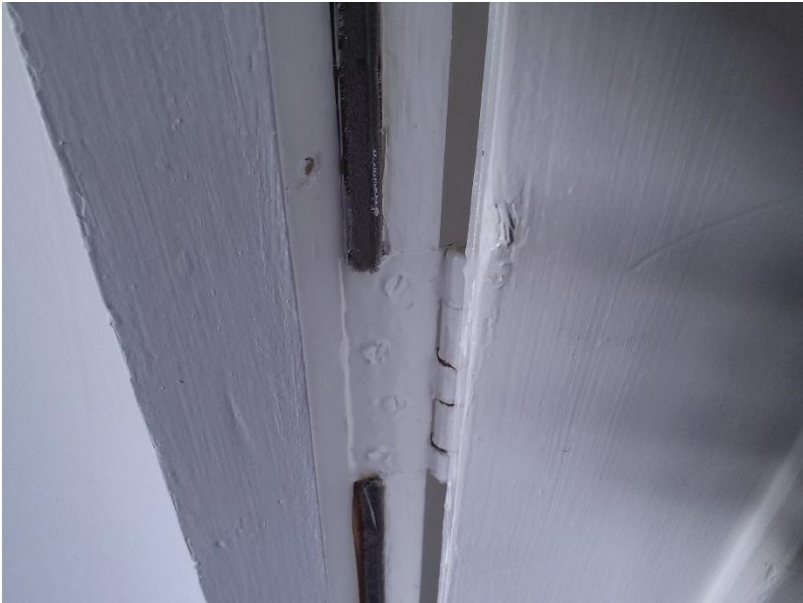
| 02 | <p>It was noted during this fire risk assessment that the identified communal area doors had the following deficiencies:</p> <ul style="list-style-type: none"> <li>• No cold smoke seals on multiple riser doors</li> <li>• Painted smoke seal on multiple lobby doors</li> <li>• No fire rated hinges on multiple lobby doors</li> </ul> <p>It is essential that each door communicating with the means of escape is a suitable fire door, providing a minimum of thirty minutes fire resistance, hung on three grade 13 hinges, combine cold smoke and intumescent seal, "Fire Door Keep Locked" or "Fire Door Keep Shut" signage where appropriate along with having a functioning self-closing device fitted that positively closes the door flush to the frame if a lobby door. It is recommended therefore that the RP instruct a suitably qualified and competent contractor to conduct a fire door inspection to all communal area doors providing advice on suitability as per "Fire Resisting Doors - 62.17" of Fire Safety in Purpose-Built Block of Flats. Any shortcomings identified by this inspection should be addressed as a priority by upgrading or replacing the door.</p> <p>Flat entrance doors, communal area doors, the seals and the self-closing devices should then be subjected to an annual inspection and maintenance schedule.</p> | 2 | B | <p>Ongoing action required</p> <p>Contractor to make appropriate repairs.</p> <p>Inspection carried out in accordance with current legislation</p> |

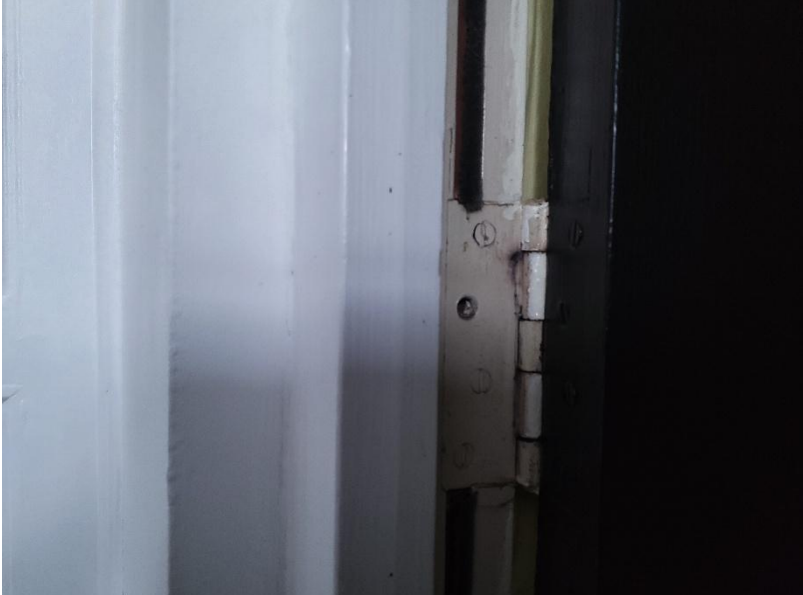
| <p>03</p> | <p>As per section 33.2 of Fire Safety in Purpose-Built Block of Flats a type 1 fire risk assessment requires us to conduct a fire door survey on a sample of flat front doors. The door to flat 28 was surveyed during this sample in which the following deficiency was found:</p> <ul style="list-style-type: none"> <li>No fire rated hinges</li> </ul> <p>It is essential that each flat entrance door is a suitable fire door, providing a minimum of thirty minutes fire resistance, hung on three grade 13 hinges and having a functioning self-closing device fitted that positively closes the door on the latch, together with smoke and intumescent seals. It is recommended therefore that the RP instruct a suitably qualified and competent contractor to conduct a fire door inspection to all flat entrance doors providing advice on suitability as per "Fire Resisting Doors – 62-12 to 62.17" of Fire Safety in Purpose-Built Block of Flats. Any shortcomings identified by this inspection should be addressed as a priority by upgrading or replacing the door.</p> <p>Flat entrance doors, communal area doors, the seals and the self-closing devices should then be subjected to an annual inspection and maintenance schedule.</p> | <p>2</p> | <p>B</p> <p>Ongoing action required</p> <p>Residents are provided with information on the importance of fire doors.</p> <p>Inspection carried out in accordance with current legislation</p> |

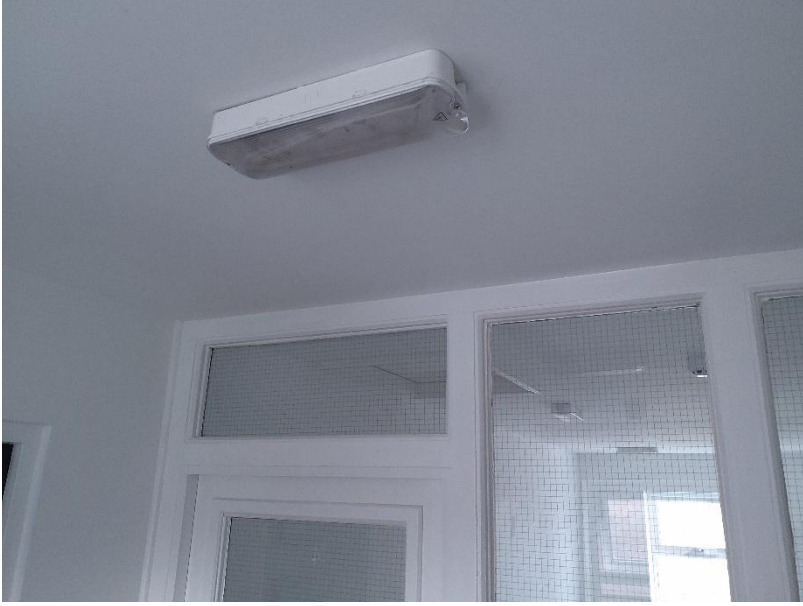
| Emergency lighting is installed within the common areas however the fixtures on the second floor do not appear to be charging. This could delay a safe and prompt evacuation in low ambient light conditions. It is recommended that the client consult with a competent contractor to conduct a light level assessment and emergency light fittings be repaired or replaced where required to ensure adequate emergency lighting levels of all escape routes. | | |

| 04 | <p>Emergency lighting is installed within the common areas however the fixtures on the second floor do not appear to be charging. This could delay a safe and prompt evacuation in low ambient light conditions. It is recommended that the client consult with a competent contractor to conduct a light level assessment and emergency light fittings be repaired or replaced where required to ensure adequate emergency lighting levels of all escape routes.</p> | 1 | B | <p>Ongoing action required</p> <p>Tested by electrician Sep 2025 with satisfactory results.</p> <p>Ongoing testing undertaken</p> |

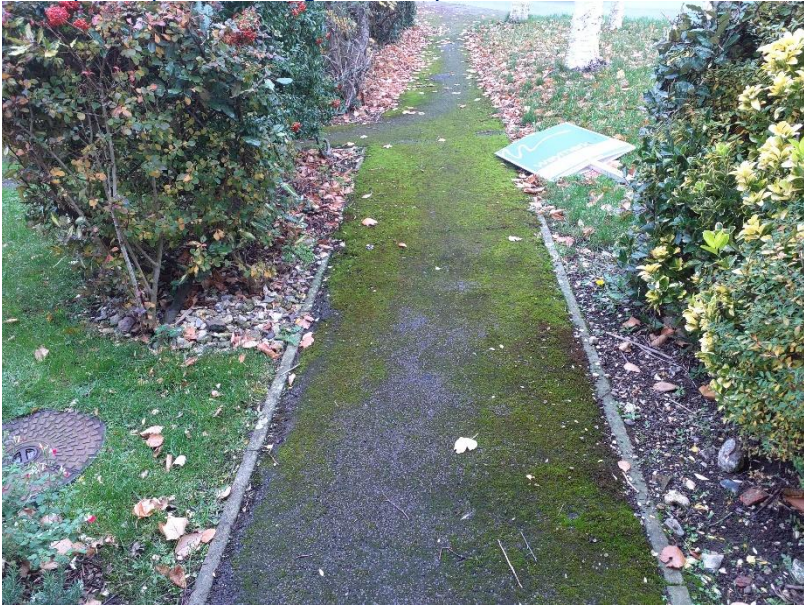
| <p>It was noted during this assessment that there is a buildup of moss on the approach paths to the premises. It is recommended that all moss be removed and the approach paths be monitored for moss buildup as it presents a significant slip hazard.</p> | | |

| 09 | <p>It was noted during this assessment that there is a buildup of moss on the approach paths to the premises. It is recommended that all moss be removed and the approach paths be monitored for moss buildup as it presents a significant slip hazard.</p> | 2 | B | <p>Action required</p> <p>Gardening contractor has been asked to remove and monitor.</p> |
